# FLEXIBLE, RESPONSIVE: VALVE REPAIR & REPLACEMENT ON LIVE HYDROCARBON SYSTEM //

A PLATFORM OPERATOR IN THE NORWEGIAN NORTH SEA HAD A PROBLEM WITH A PASSING VALVE RELATED TO THE SECOND STAGE SEPARATOR CONTAINING HYDROCARBONS AT 90 BAR (1300 PSI) AND 75 DEGREES C (165 DEGREES F).

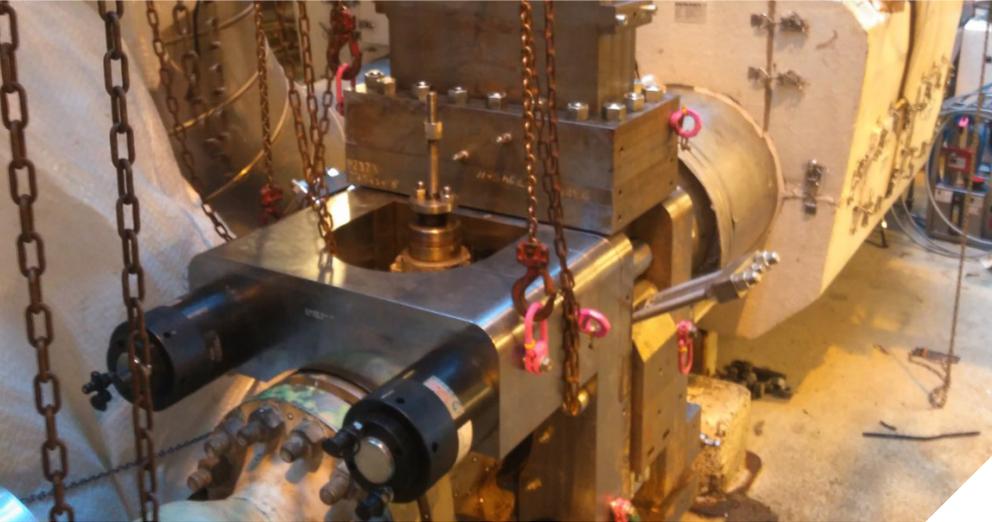
FROM INITIAL ENQUIRY, IK-GROUP DESIGNED, ENGINEERED AND IMPLEMENTED A SOLUTION IN JUST EIGHT WEEKS, WITH NO LOSS OF PRODUCTIVE TIME. THE AOGV MECHANICAL ISOLATION TOOL WAS TESTED, CERTIFIED AND CE MARKED PRIOR TO MOBILISATION.

The AOGV facilitated intrusive maintenance on the passing valve by use of isolation spades set in between the valve and pipe spools leading to the second stage separator.

The AOGV’s isolation spades were set on each side of the leaking valve, creating a hydrocarbon- and pressure-freed valve cavity.

With the valve discovered to be in far worse condition than anticipated, IK-Group was tasked with creating a solution to completely remove the valve from the system and replace. Within seven days, we conceptualised, designed, manufactured and tested three bespoke isolation spades with integral bleed ports, to facilitate replacement of the passing valve from the line.

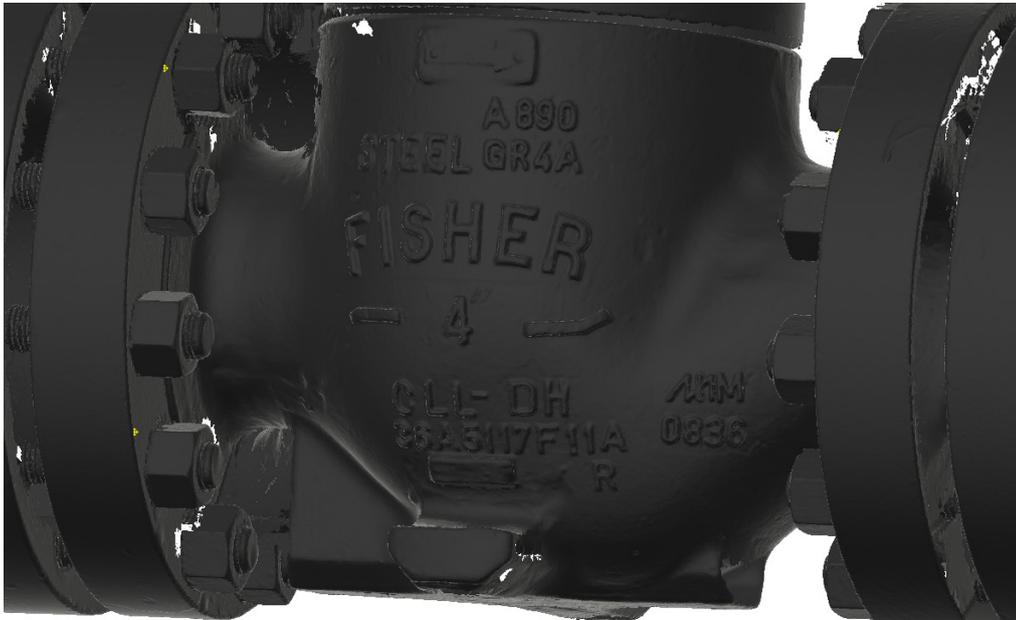
*High precision 3D scan result.*

IK-Group conducted an on-site survey - including a high precision 3D scan – allowing us to create an AOGV which was 100% aligned to the flanged valve. With obstacles on both sides of the passing valve, the AOGV was specially-designed and manufactured to fit around a parallel 1” valve and blind flange on one side, in addition to a 6” valve located on the other side of the valve.

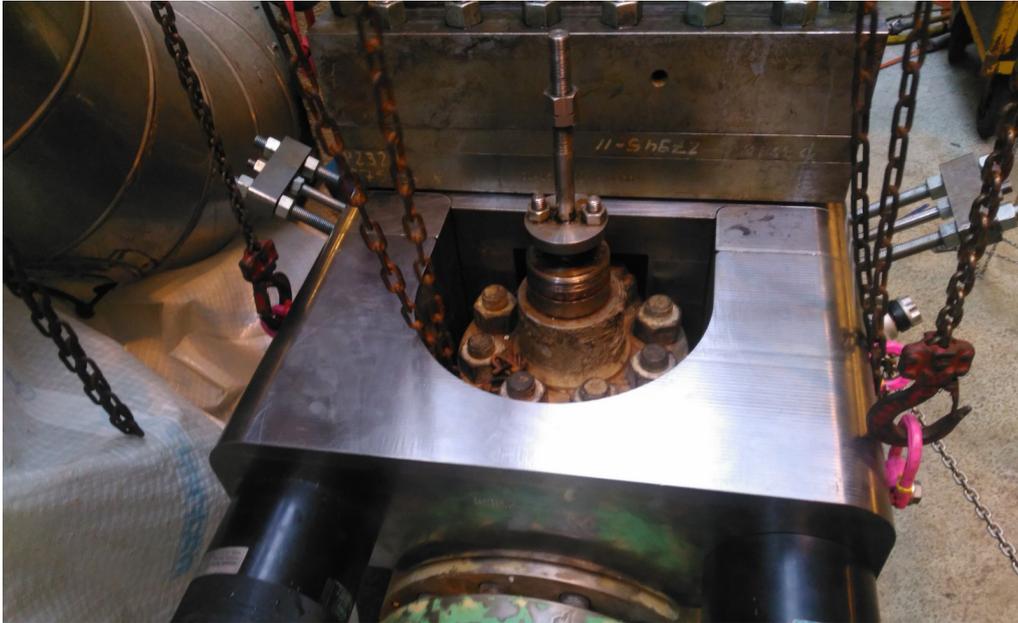
*Integrity clamp designed around the valve housing.*
